# FIELD EXPERIENCES

February 4, 2003

# Field Experiences

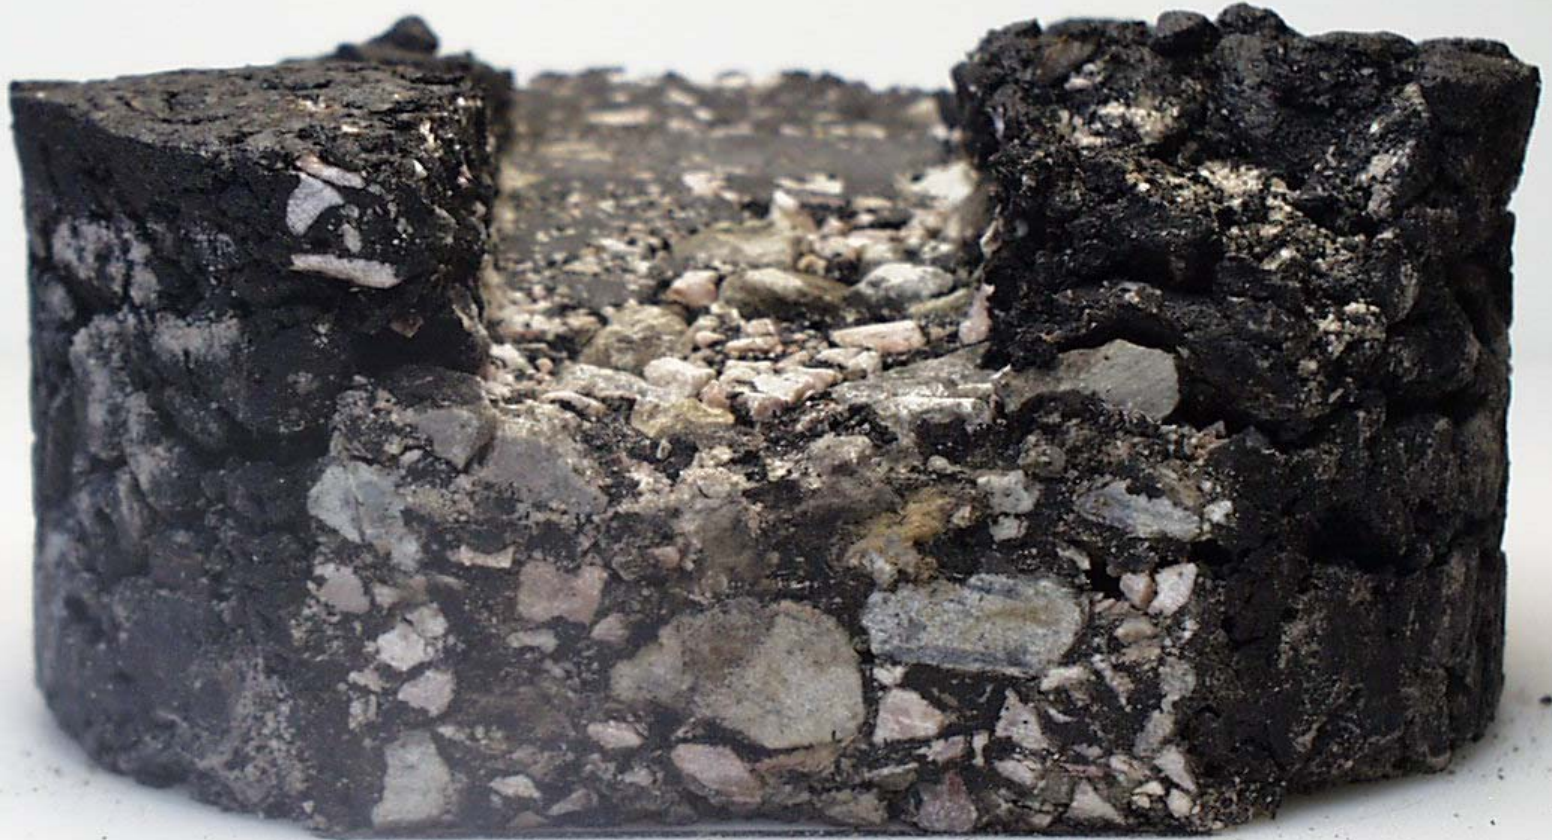
District: "Research"	Mix Type: CMHB-C	Binder: 70-22
Aggr.: Limestone	Additive: None	ID: 540067

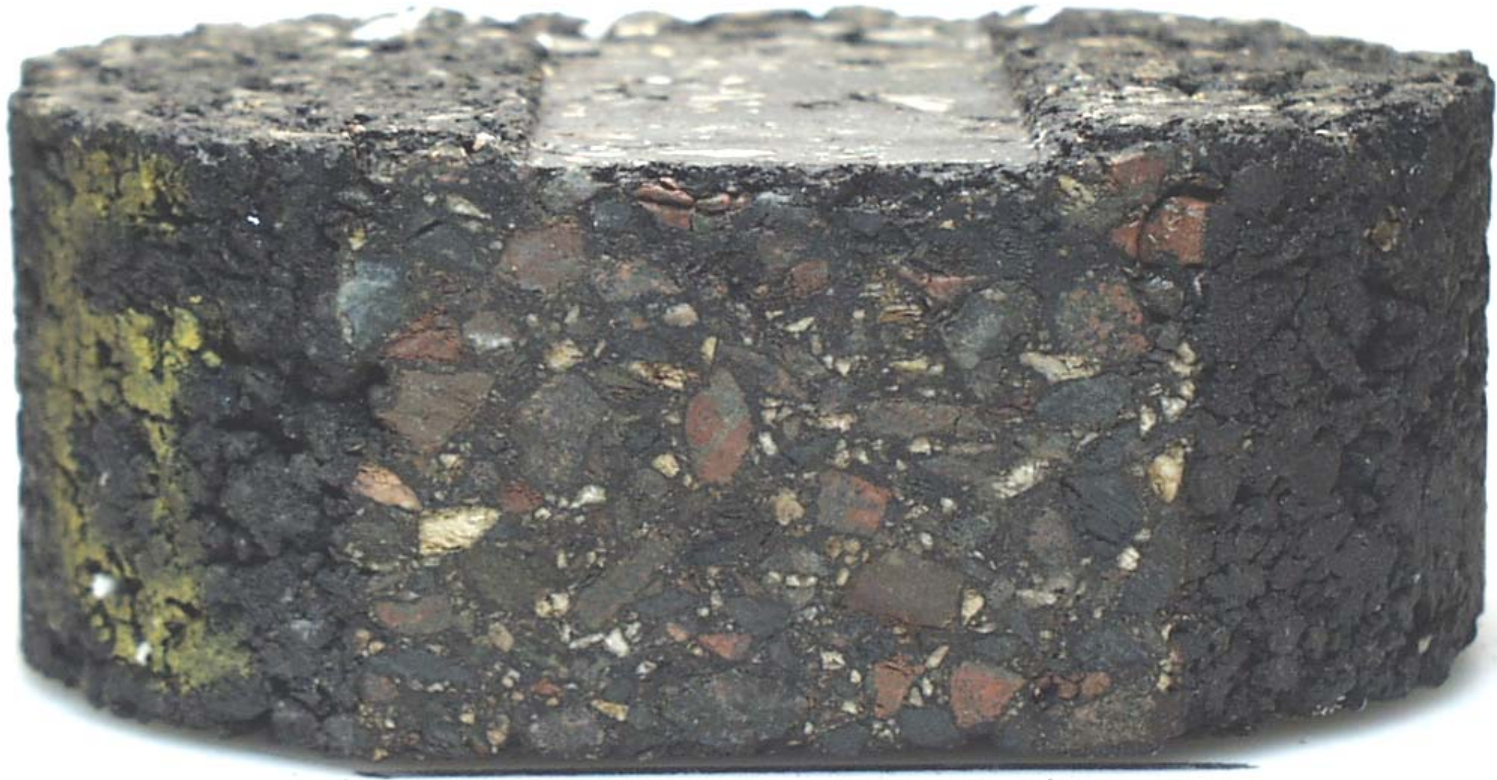
District: W.Falls

Mix Type: Superpave (0.5) Binder: 76-22

Aggr.: Granite+

Additive: Lime(1%)

Rutting: 12.5 mm

# of Passes: 10,200

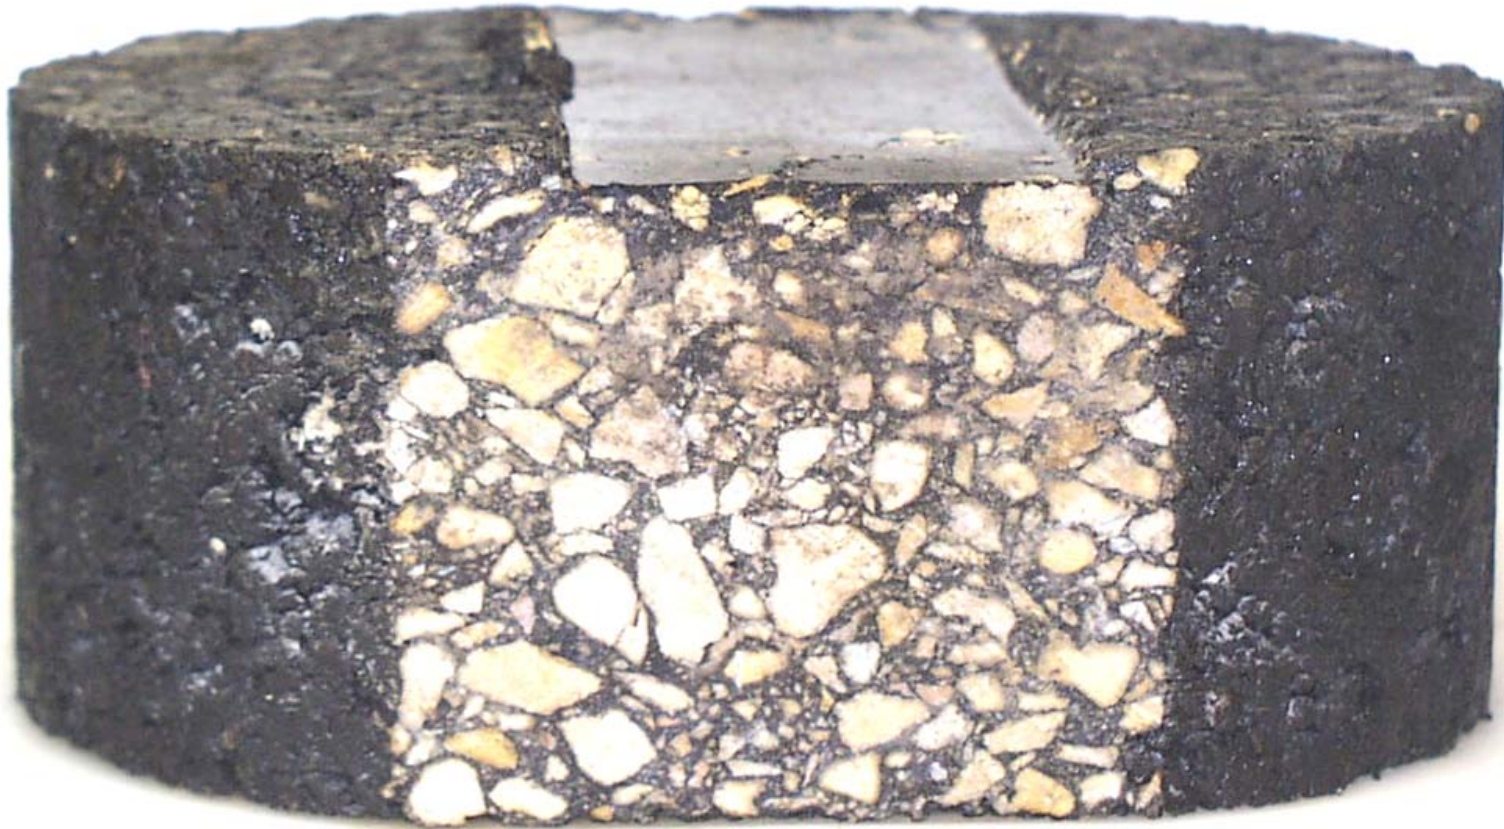
District: Abilene

Mix Type: Superpave

Binder: 76-22 (Source 2)

Aggr.: Limestone

Additive: None

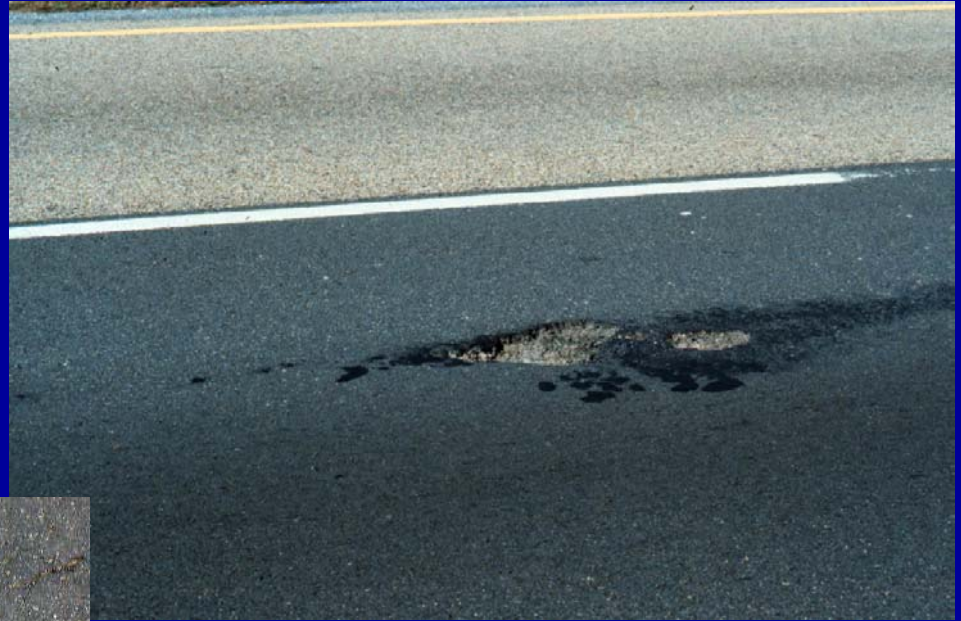
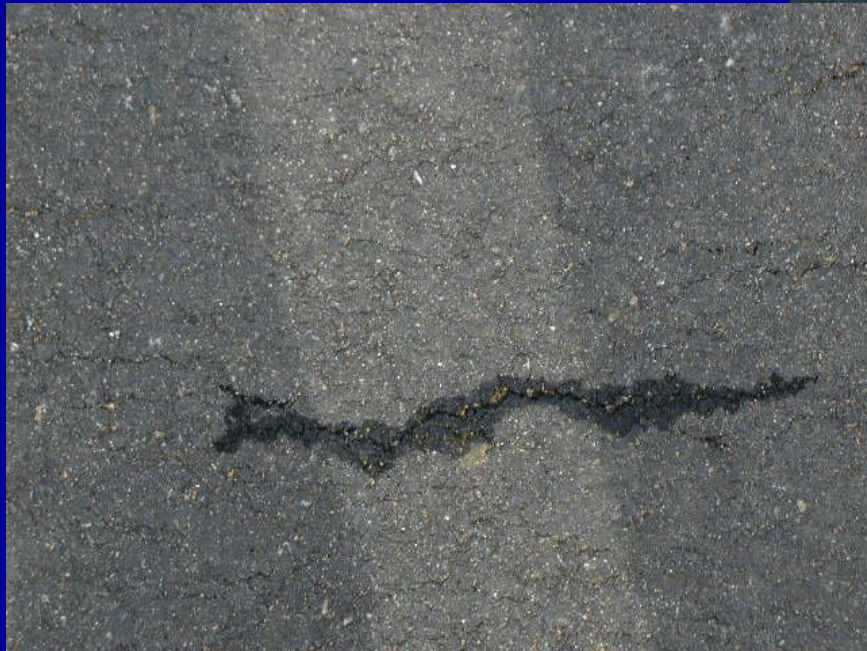
# TYPICAL PAVEMENT DISTRESSES

30 Years Ago

Today

- Began to recognize in late 1960's
- Failures were often catastrophic
- Started to use additives in early 1970's
- Instituted use of TSR test for mix design
- Although distresses are not catastrophic a recent survey revealed considerable stripping in cores
